Water Facts 6

Protecting Wells with Sanitary Well Caps and Grouting

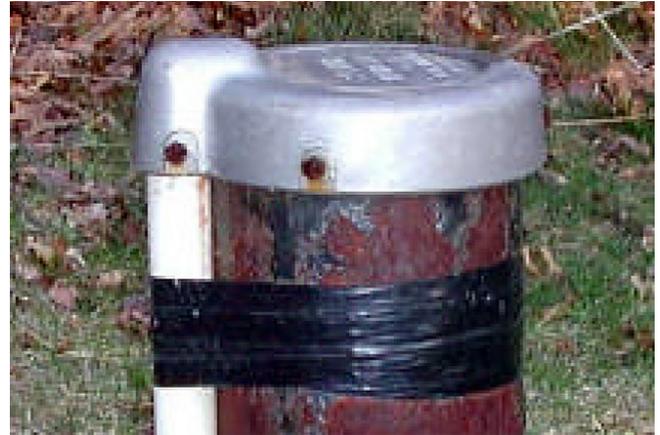
Figure 1. A standard well cap similar to those found on most Pennsylvania wells (note the bolts around the outside of the well cap).

Most existing and new wells in Pennsylvania have a standard well cap similar to the one shown in Figure 1. Standard well caps usually have bolts around the side of the cap that loosely hold the cap onto the top of the casing. The small airspace between the well cap and the casing can allow for insects, small mammals, or surface water to enter the well.

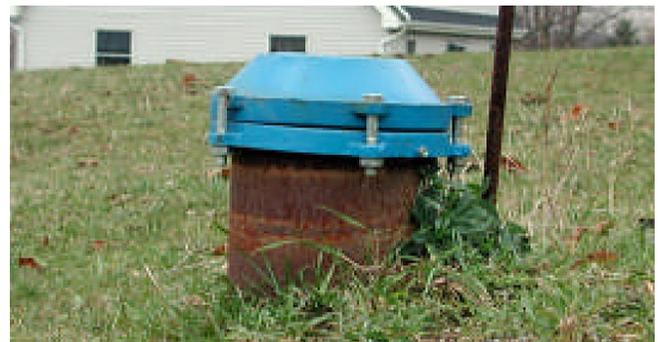
Figure 2. A sanitary well cap installed on a well casing. Note the bolts on the top rather than around the sides of the cap.

A “sanitary” well cap (sometimes referred to as a “vermin-proof” well cap) looks similar to a standard well cap but usually has bolts on the top of the well cap as shown in Figure 2. Most sanitary well caps include an airtight rubber gasket seal to prevent insects, small mammals, or surface water from entering the well and a small, screened vent to allow for air exchange (Figure 3).

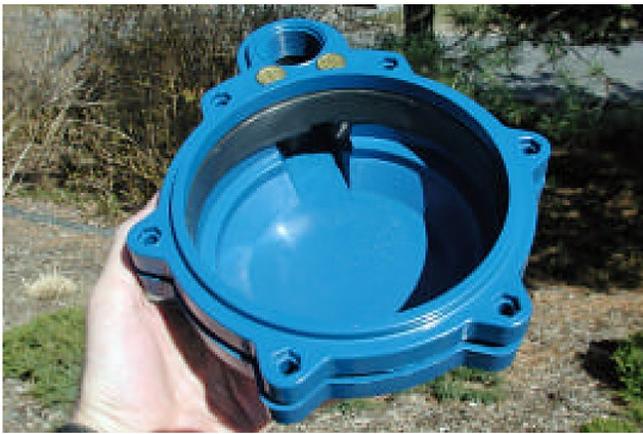
Figure 3. A sanitary well cap showing the rubber gasket, hole for electrical conduit, and screen holes for ventilation.

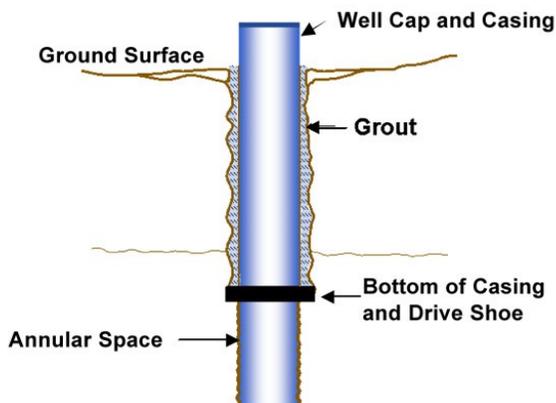
Figure 4. Cross-section of a well casing showing the grout used to seal the annular space around the casing.

Grout is usually neat cement (no aggregate) that is pumped into the space between the drilled hole and the casing—called the *annular space* (Figure 4). Bentonite, a clay material that expands when wet, is also often used for grouting a well. The grout is pumped into the annular space starting from the bottom of the casing using a tremie pipe until it appears at the surface of the ground (Figure 5). Grout is usually not used on private wells in Pennsylvania unless it is required by local ordinances or requested by the homeowner.

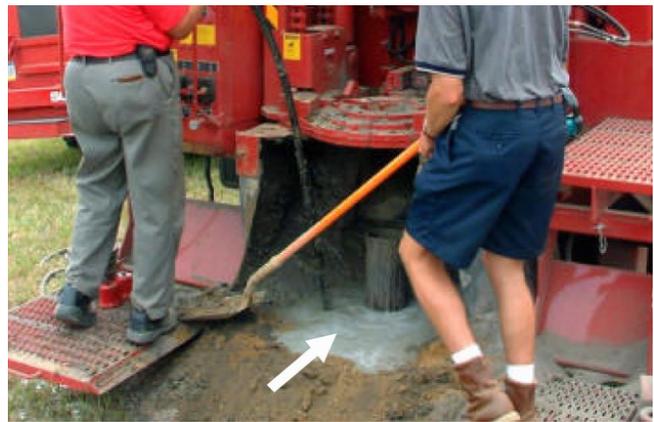
Figure 5. Well drillers use a tremie pipe to pump grout into the well. Note that the grout is now appearing at the surface of the ground around the well casing—see arrow (Photo by Dr. Todd Giddings).
